| IN RE: ETHICON, INC., PELVIC REPAIR SYSTEM PRODUCTS LIABILITY LITIGATION | Master File No. 2:12-MD-02327 MDL 2327 JOSEPH R. GOODWIN U.S. DISTRICT JUDGE |

Intentional Oxidation of Prolene Mesh – Part 2

Supplemental Report of Dr. Shelby F. Thames

September 28, 2016

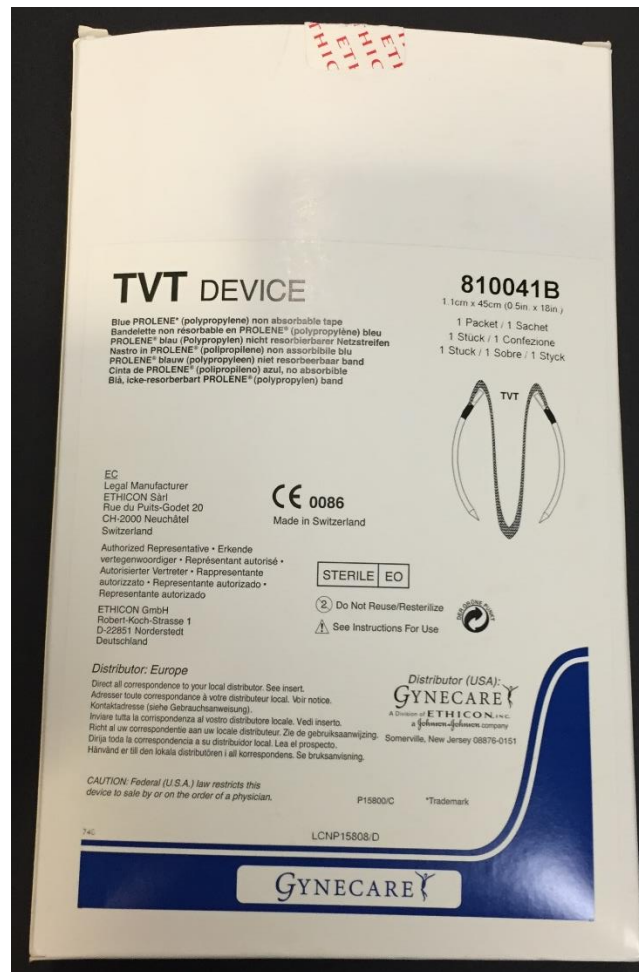
Figure 2. Exemplar Gynecare TVT Device 810041B

A sample size of approximately 10 mm x 10 mm of the exemplar TVT device, lot 810041B, as noted in Figures 2 and 3, was placed in the UV exposure chamber (Figure 4).

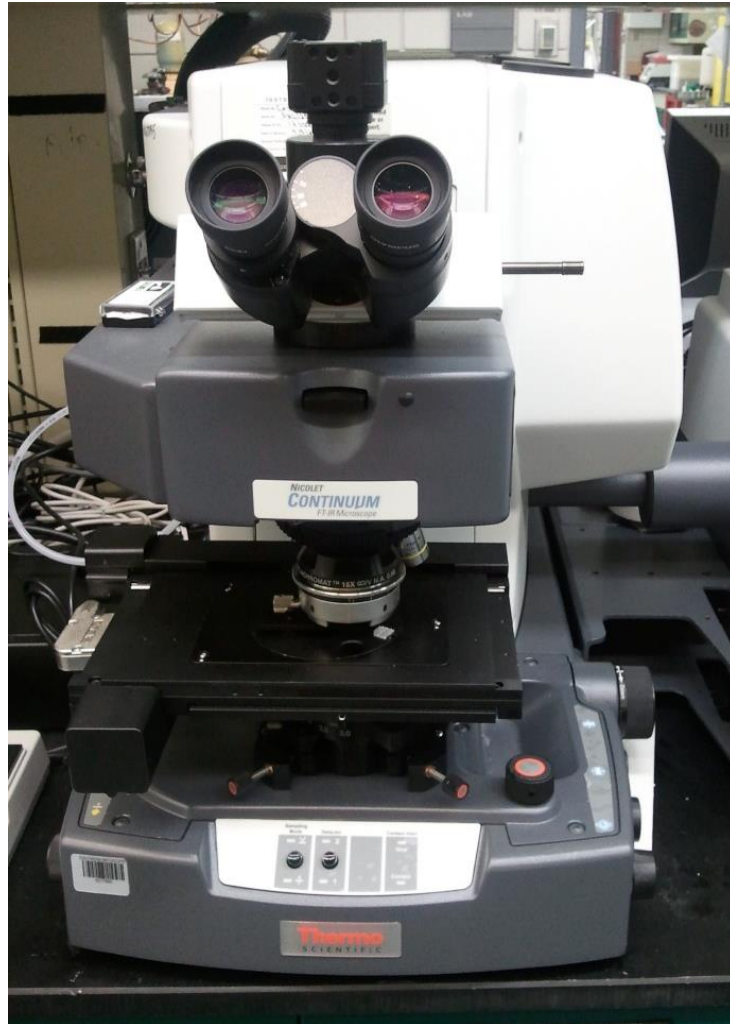
Figure 5. Thermo-Nicolet Continuum FTIR Microscope

The pristine TVT exemplar sample was characterized via Fourier Transform Infrared Microscopy (FTIR) with a Thermo-Nicolet Continuum FTIR Microscope (Figure 5) prior to UV exposure. The resulting spectrum (Figure 6) contains an inset image showing the penetrating IR beam location. The absorption frequency at 1742 cm^{-1} , indicative of Ethicon's DLTDP antioxidant, is also noted in my previous reports, which I rely upon, and is present in the spectrum.
